Node Inspection - 3/07/2019 - SMH.08532432

Date of inspection 3/07/2019	Node name SMH.08532432	Node type Sewer Maintenance Hole	Town Brisbane	Location/Street 34 Serenity DR	No. 3.00
Name of operator Hugh	Precipitation No precipitation	Pre-cleaned Yes		Depth to Invert [m] 3.53	Job Number 1

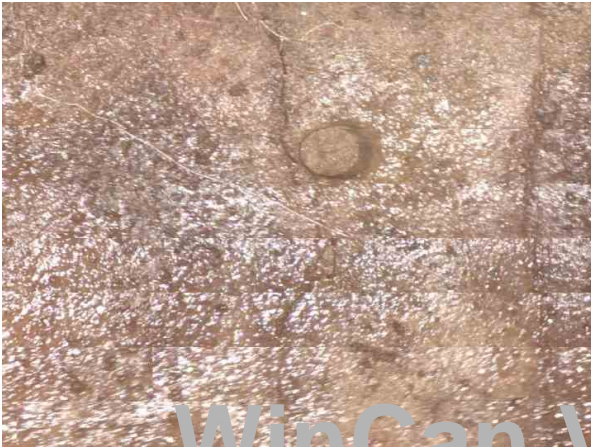
1, , 0.47
 Ladder support missing (Ladder clip missing).

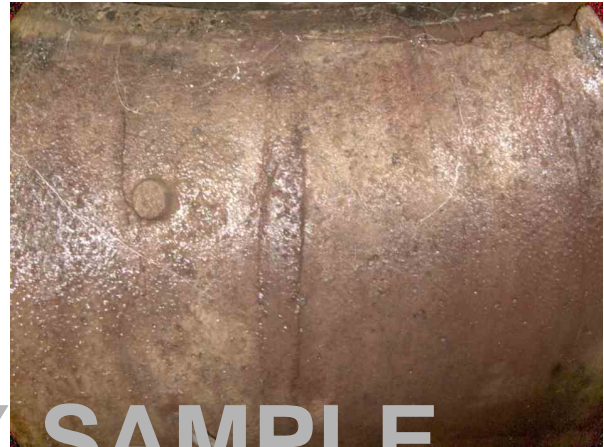
2, , 0.47
 Ladder support missing (Ladder clip missing).

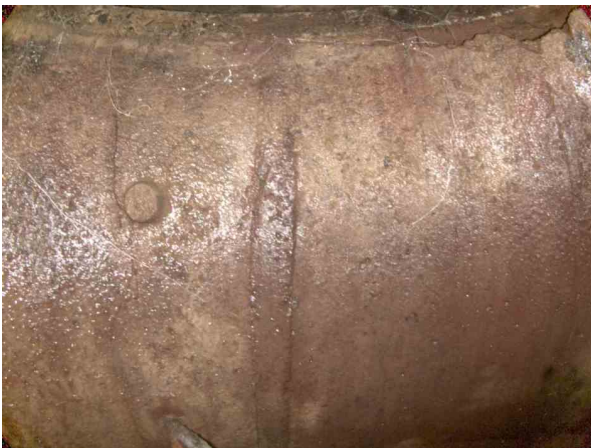
3, , 3.19
 Ladder support missing (Ladder clip missing).

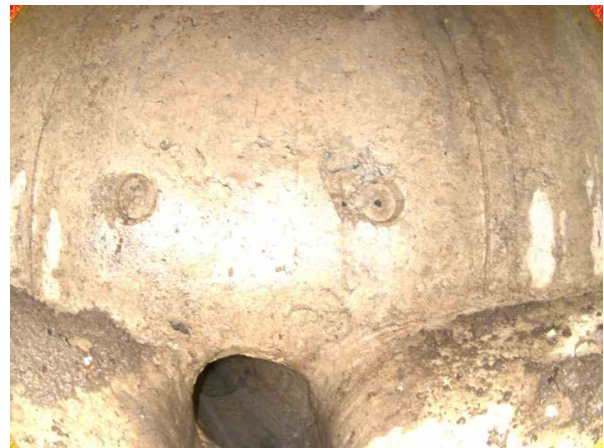
4, , 3.49
 A conduit connecting to the maintenance structure, circular, incoming. at 1 o'clock
