Node Inspection - 3/07/2019 - SMH.08186234

Date of inspection 3/07/2019	Node name SMH.08186234	Node type Sewer Maintenance Hole	Town Brisbane	Location/Street 4 Meger ST	No. 1.00
Name of operator Hugh	Precipitation No precipitation	Pre-cleaned Yes		Depth to Invert [m] 6.81	Job Number 1

Node material Brickwork	Shape of Access Rectangular	Width of access 1050.00	
-----------------------------------	---------------------------------------	-----------------------------------	--

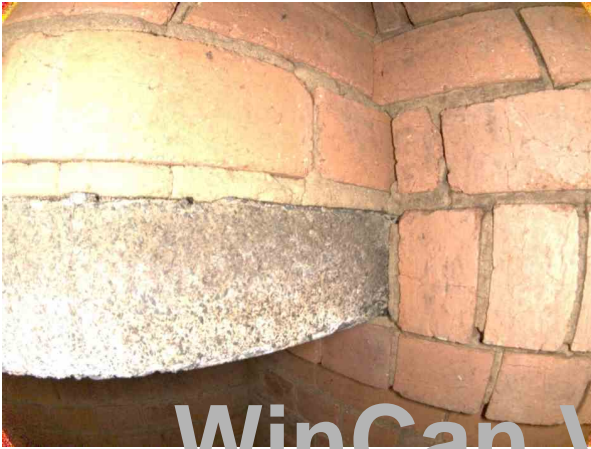
1, , 0.64
 All or part of the mortar from masonry is missing, 5mm from 5 o'clock to 10 o'clock

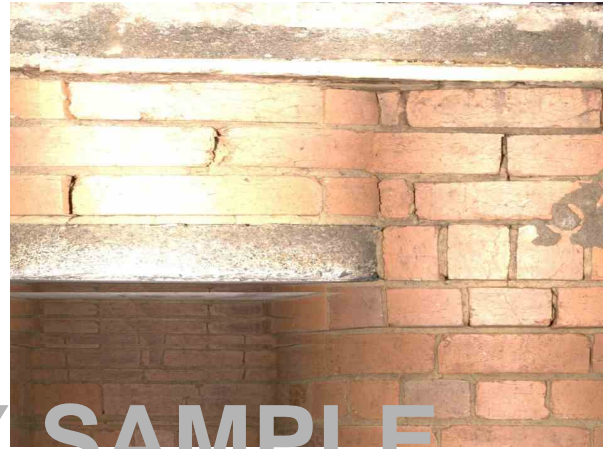
2, , 0.64
 All or part of the mortar from masonry is missing, 5mm from 5 o'clock to 10 o'clock

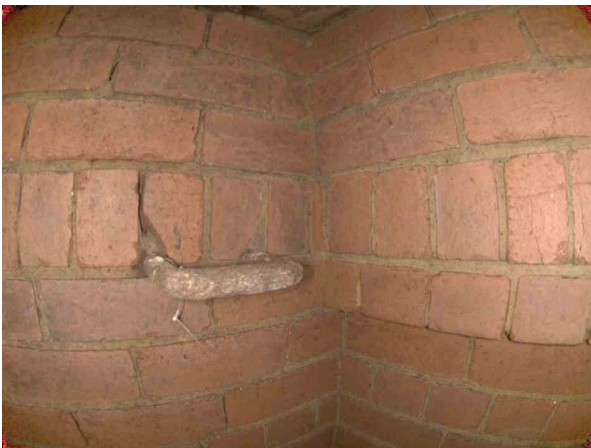
3, , 0.71
 The regularity of the original bond pattern has been disturbed, 5mm from 12 o'clock to 2 o'clock

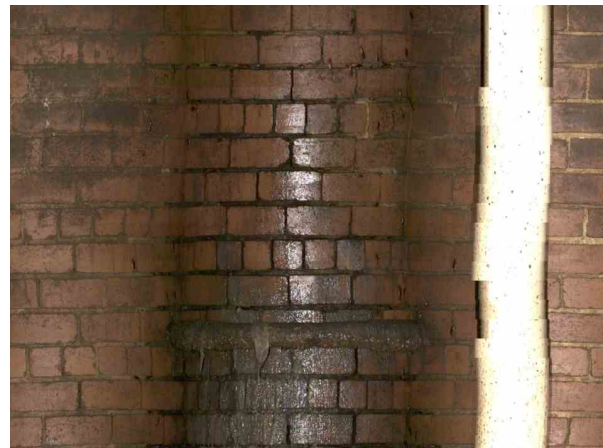
4, , 5.23
 All or part of the mortar from masonry is missing, 10mm from 5 o'clock to 8 o'clock

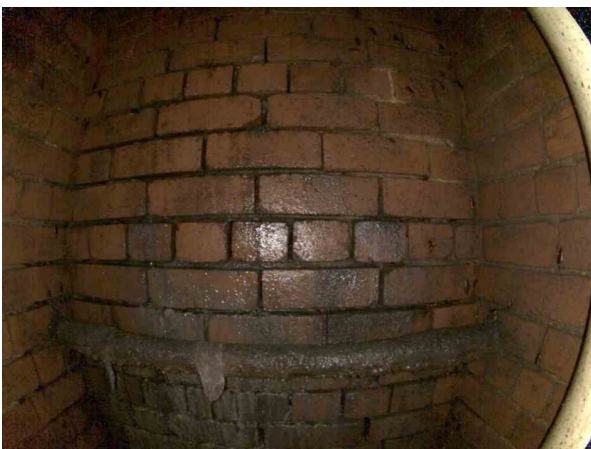
5, , 5.23
 All or part of the mortar from masonry is missing, 10mm from 5 o'clock to 8 o'clock

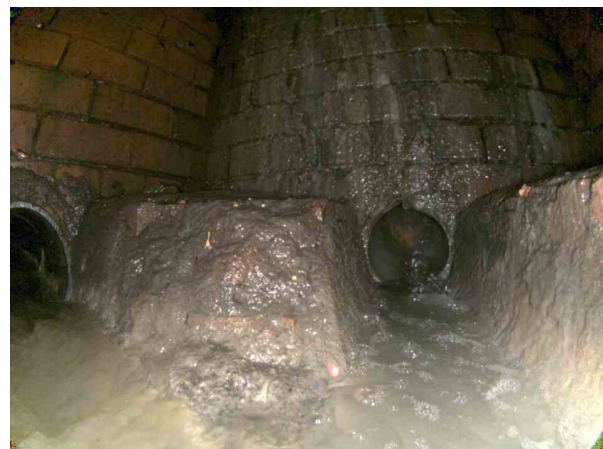
6, , 6.55
 A conduit connecting to the maintenance structure, circular, incoming., Ht/Dia # 150mm at 6 o'clock
